2010 Annual Inspection Report

Barataria Bay Waterway West Bank Protection

State Project Number BA-23
Priority Project List 4

December 13, 2010
Jefferson Parish

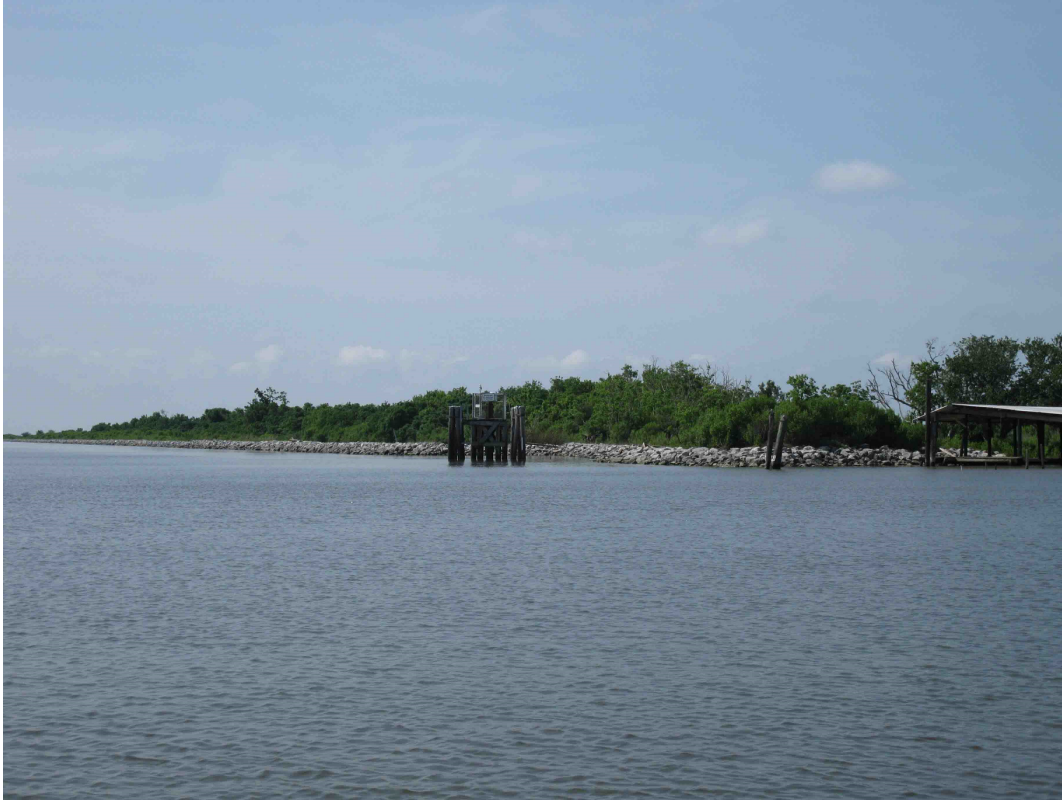
The rock structure appeared to be in good condition at the time of the inspection (Photo #1). There are some sections of settlement, but the structure is still functioning as designed. These sections will continue to be monitored for maintenance needs.

Photo #1 – Shoreline Protection Looking South.

- Continue to check the water control structure during operational procedures.
- Continue to observe rock structure for settlement.

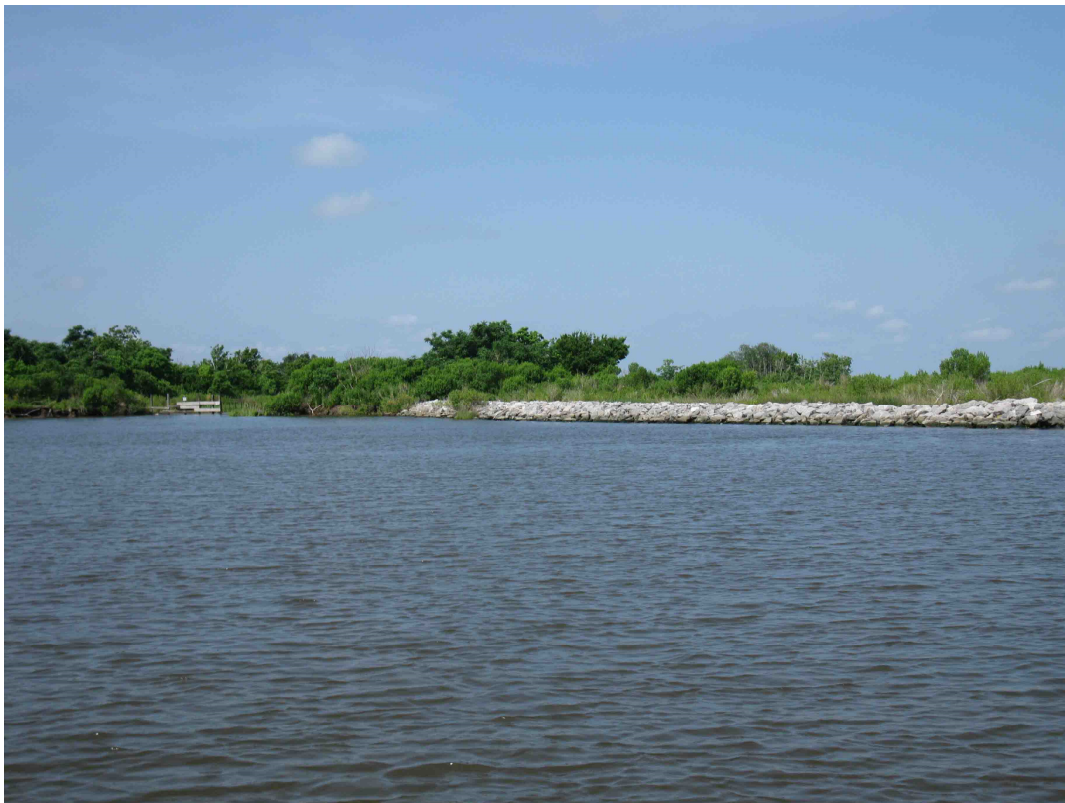
The water control structure has remained closed this year due to the BP oil spill in the Gulf of Mexico. Once this threat is no longer present the structure will be opened. The water control structure is accessed through an abandoned oil well canal. The landowner has informed me that a well will be drilled directionally from the canal used to access the structure. He stated that they will not do any work that will block the flow of water through the structure. Also, all material dredged to access the work site will be placed inside the project area to create marsh since this will impact the marsh created from the maintenance dredging in 2007.

Photo #2 – Access Canal Gate to Water Control Structure.
